Whitlock Gear/Throttle Lever Seal

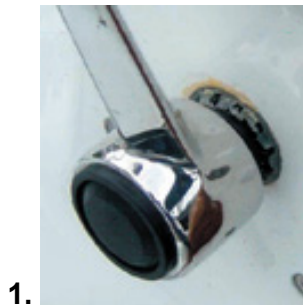
When we received our Bavaria 36, I was surprised how poor the seal was between the throttle/gear lever and the binnacle. It was made from sponge rubber and appeared to have little UV protection. After a few months it fell off (see photo). I didn't bother too much until the Gins Farm rally when the owner of a Bavaria 36, a little older than ours, reported that his push button to disengage the throttle from the gear had seized. I therefore discussed this with Opal but by then the boat was out of the initial warranty and anyway the only solution proposed by Russell Asser was to remove the control and replace it with the same! At the Southampton Boat Show he had even shown me new boats on which the seals were already disintegrating. One was a Bavaria 38!! As winter approaches, I didn't want to leave the shaft unprotected and suffer a seized disengage button. The following is, I think, a good, cheap, quick but possibly temporary solution.
